GEOTECHNICAL AND GEOLOGICAL
RECONNAISSANCE STUDY

PROPOSED IONE CASINO AND HOTEL
TREATED WATER SEASONAL STORAGE
RESERVOIR
AMADOR COUNTY, CALIFORNIA

Project No. S8874-06-01
Draft Date: August 20, 2004
Revised April 29, 2005

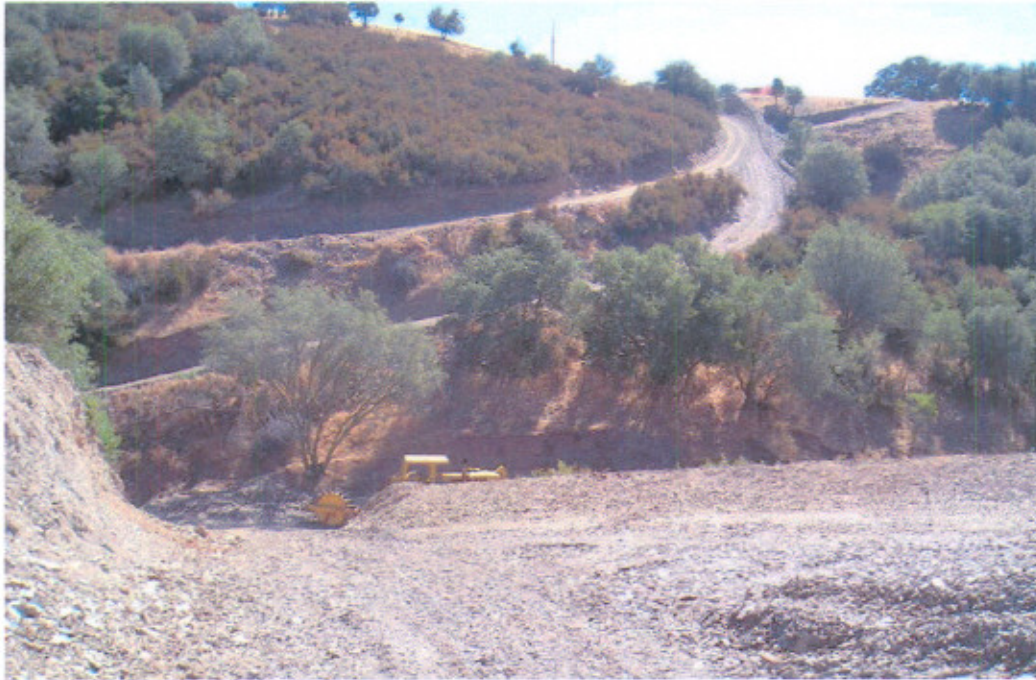
Photo No. 1 Unpaved Access Roads Traversing the Site

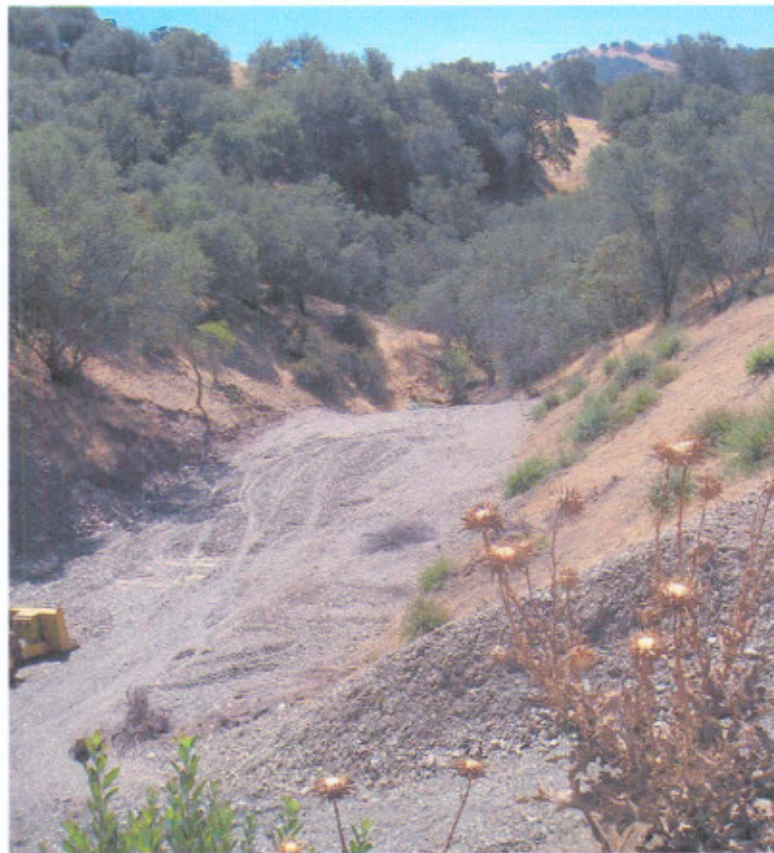
- The Site is underlain by fill material, residual soil, alluvium and Mariposa Formation bedrock.
- The maximum thickness of the fill material (at the time of our reconnaissance and field exploration) is approximately 12 feet. The fill soil is in a relatively loose condition and overlies alluvial material with a significant organic content.

Photo No. 2 Fill Material Placed in Canyon at the Site (Looking Downstream)

- The fill, alluvium and residual soil are not considered suitable foundation materials for the embankment dam. The materials should be completely removed within the footprint of the embankment. With the exception of the fill material, the depth or thickness of these materials is expected to be on the order of 5 feet or less. Localized areas could be thicker.

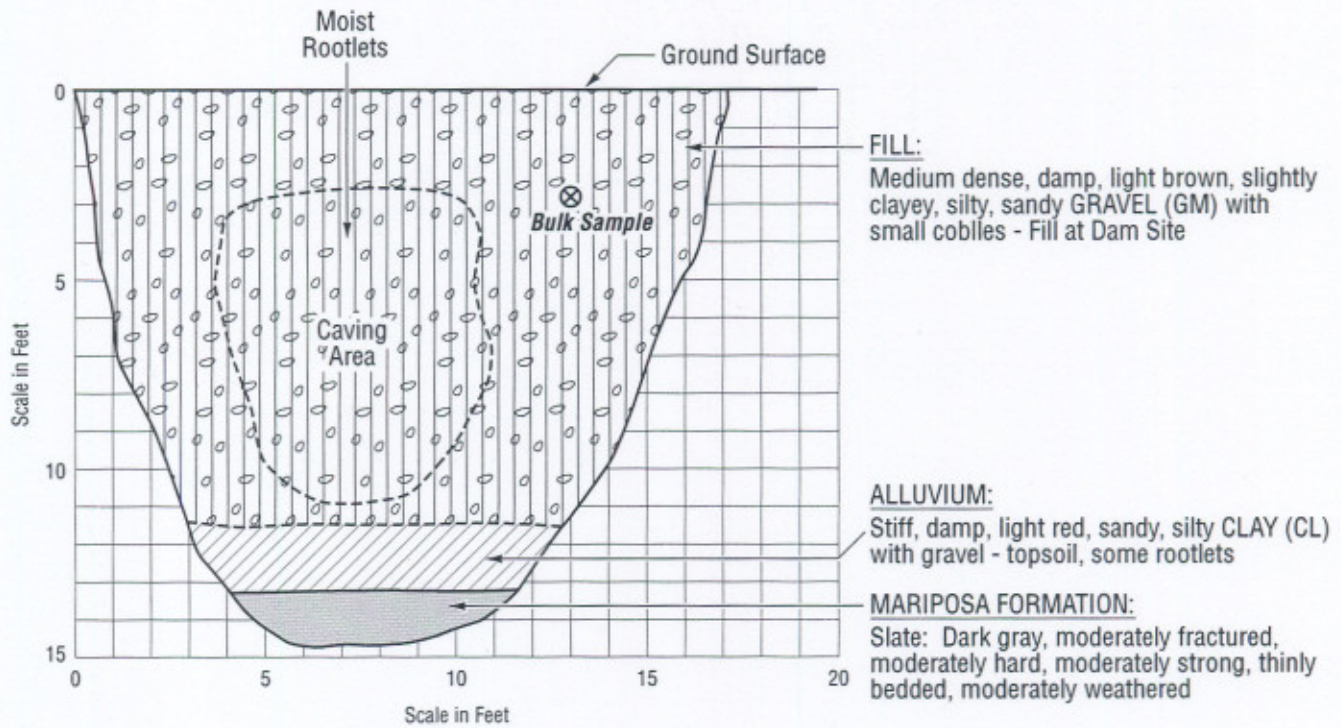
Figure A1

TP1 West Wall Profile

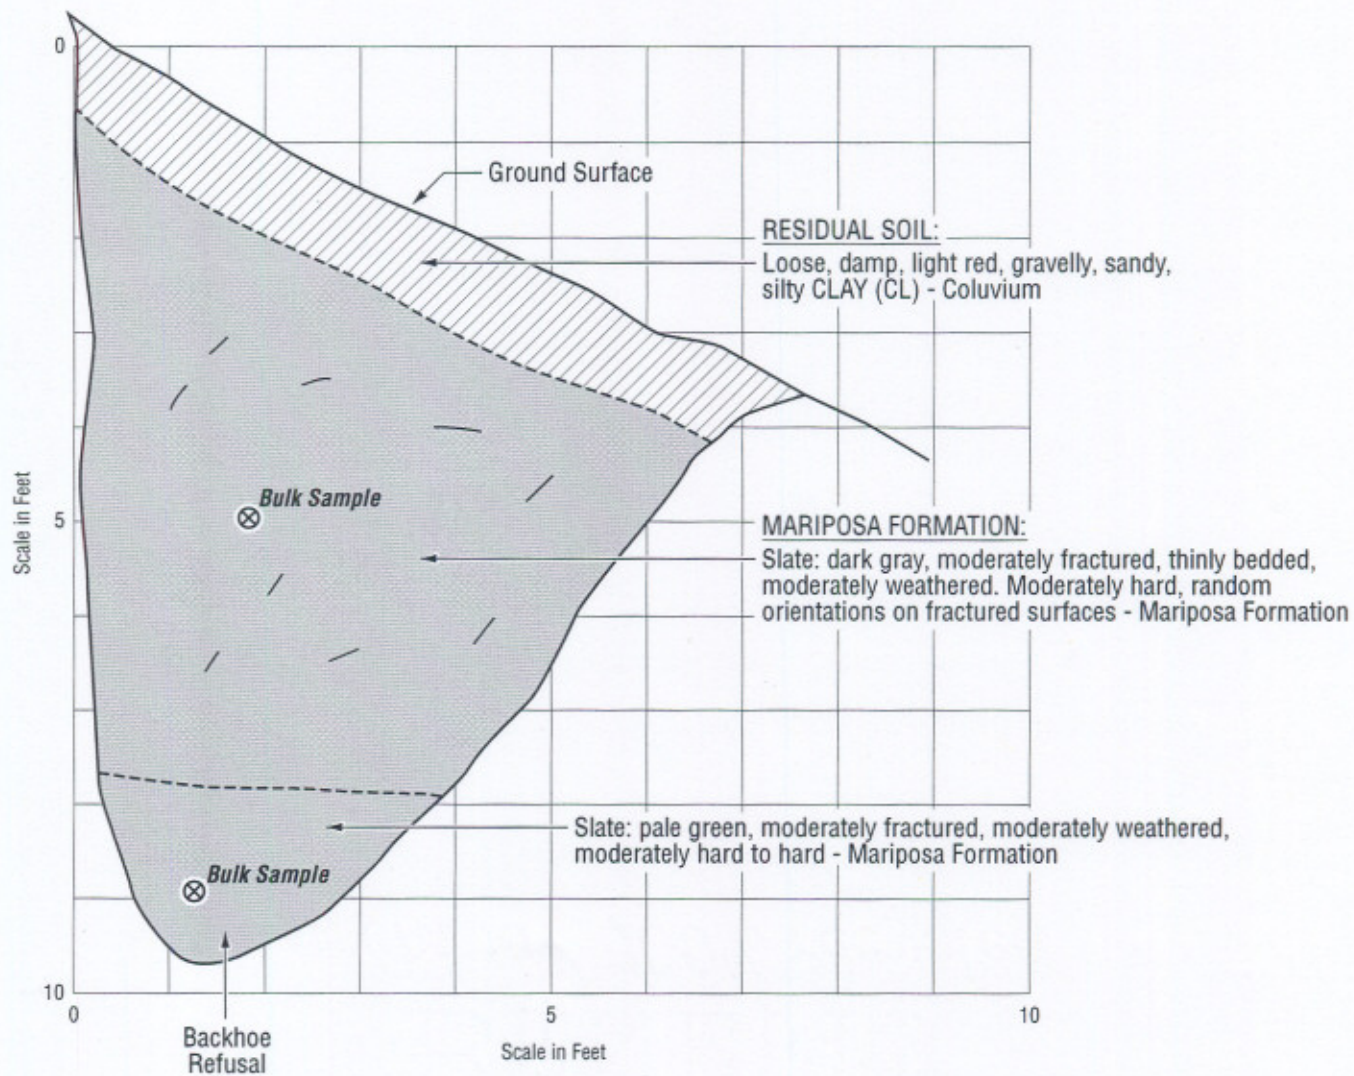
Figure A2

TP2 Northeast Wall Profile

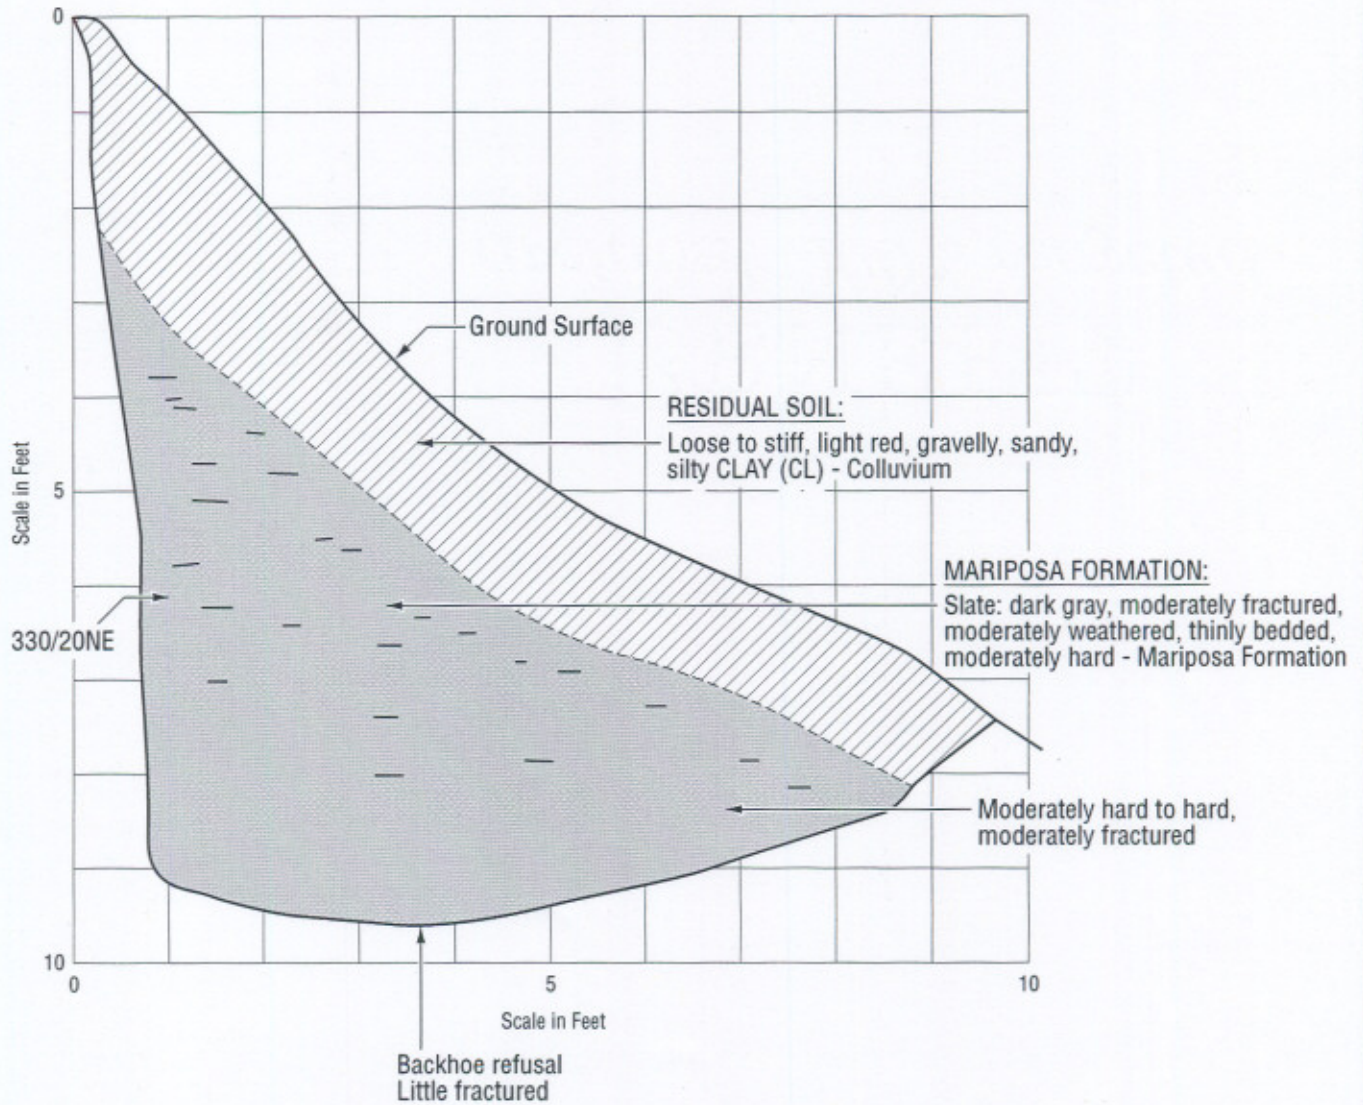
Figure A3

TP3
Southwest Wall Profile

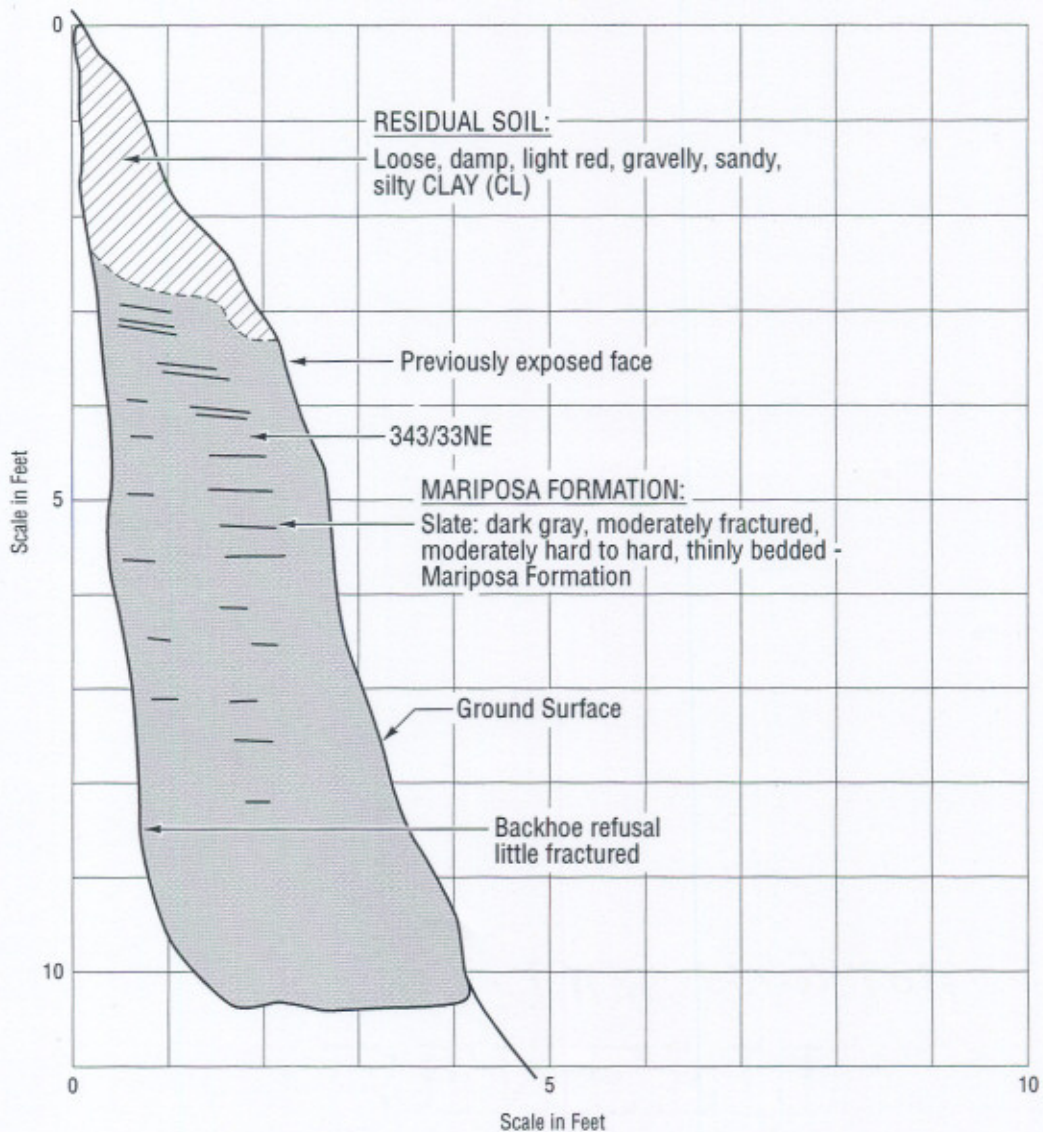
Figure A4

TP4 Southwest Wall Profile

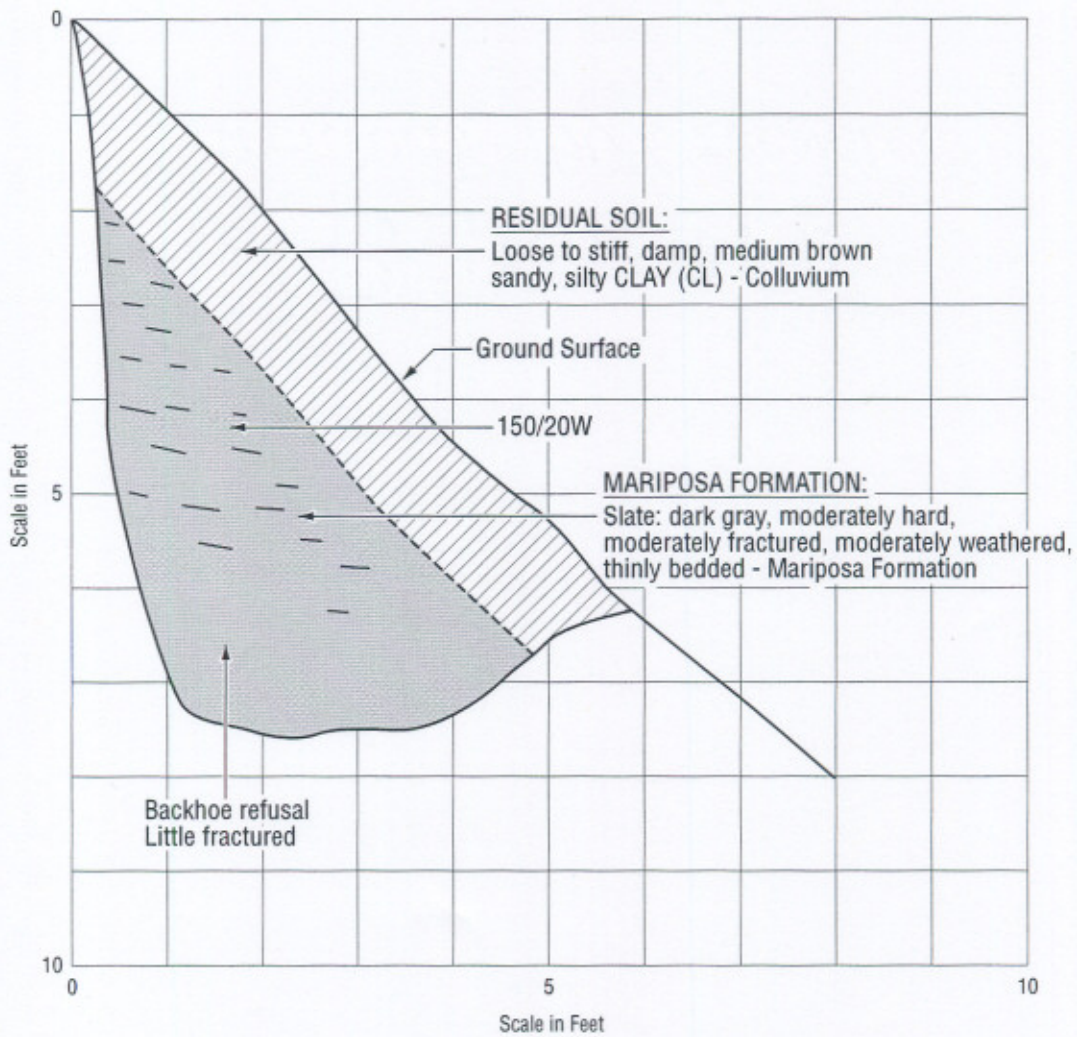
Figure A5

TP5
Northwest Wall Profile

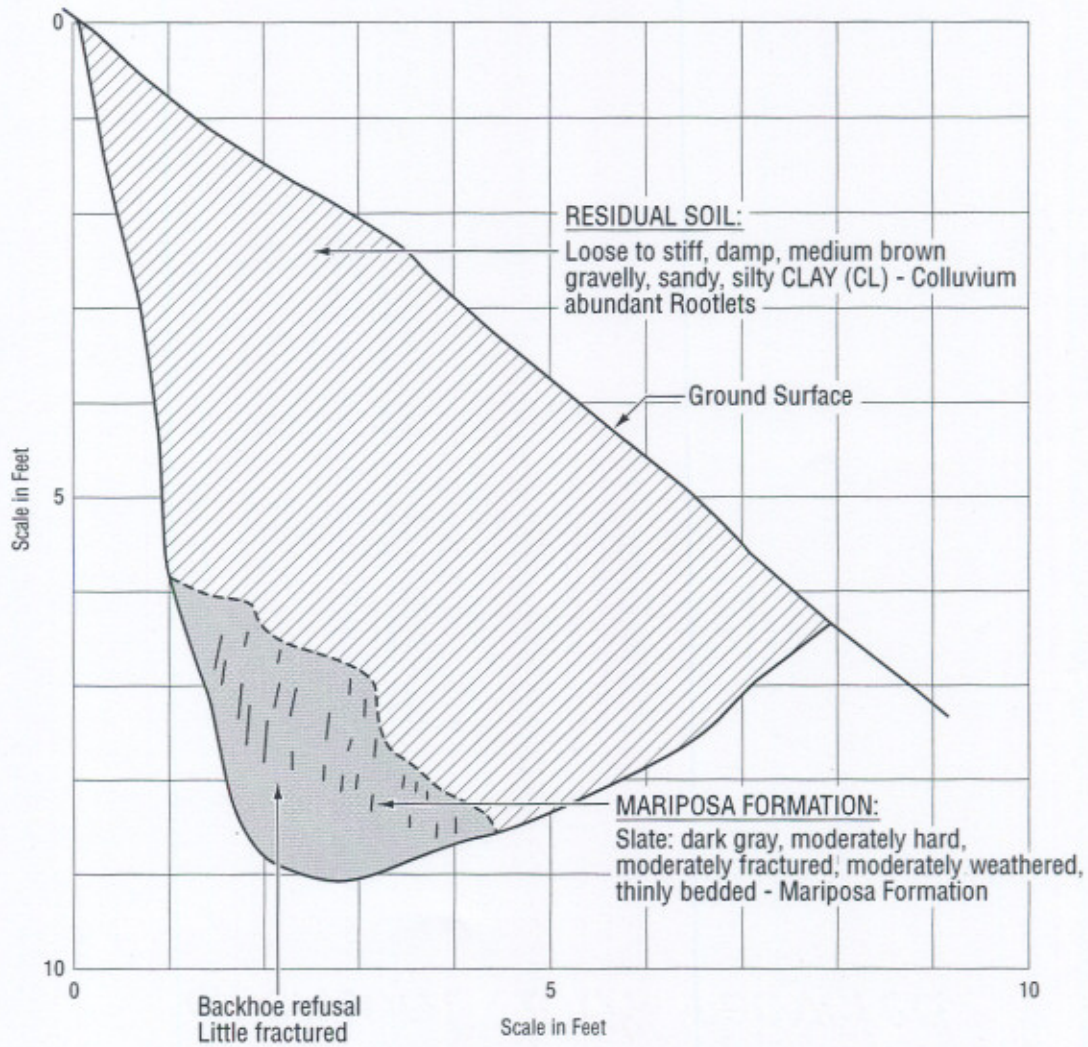
TP6
Northeast Wall Profile
