GEOTECH REPORT FOR WASTEWATER FACILITY

GEOTECHNICAL AND GEOLOGICAL
RECONNAISSANCE STUDY

PROPOSED IONE CASINO AND HOTEL
TREATED WATER SEASONAL STORAGE
RESERVOIR
AMADOR COUNTY, CALIFORNIA

Project No. S8874-06-01
Draft Date: August 20, 2004
Revised April 29, 2005

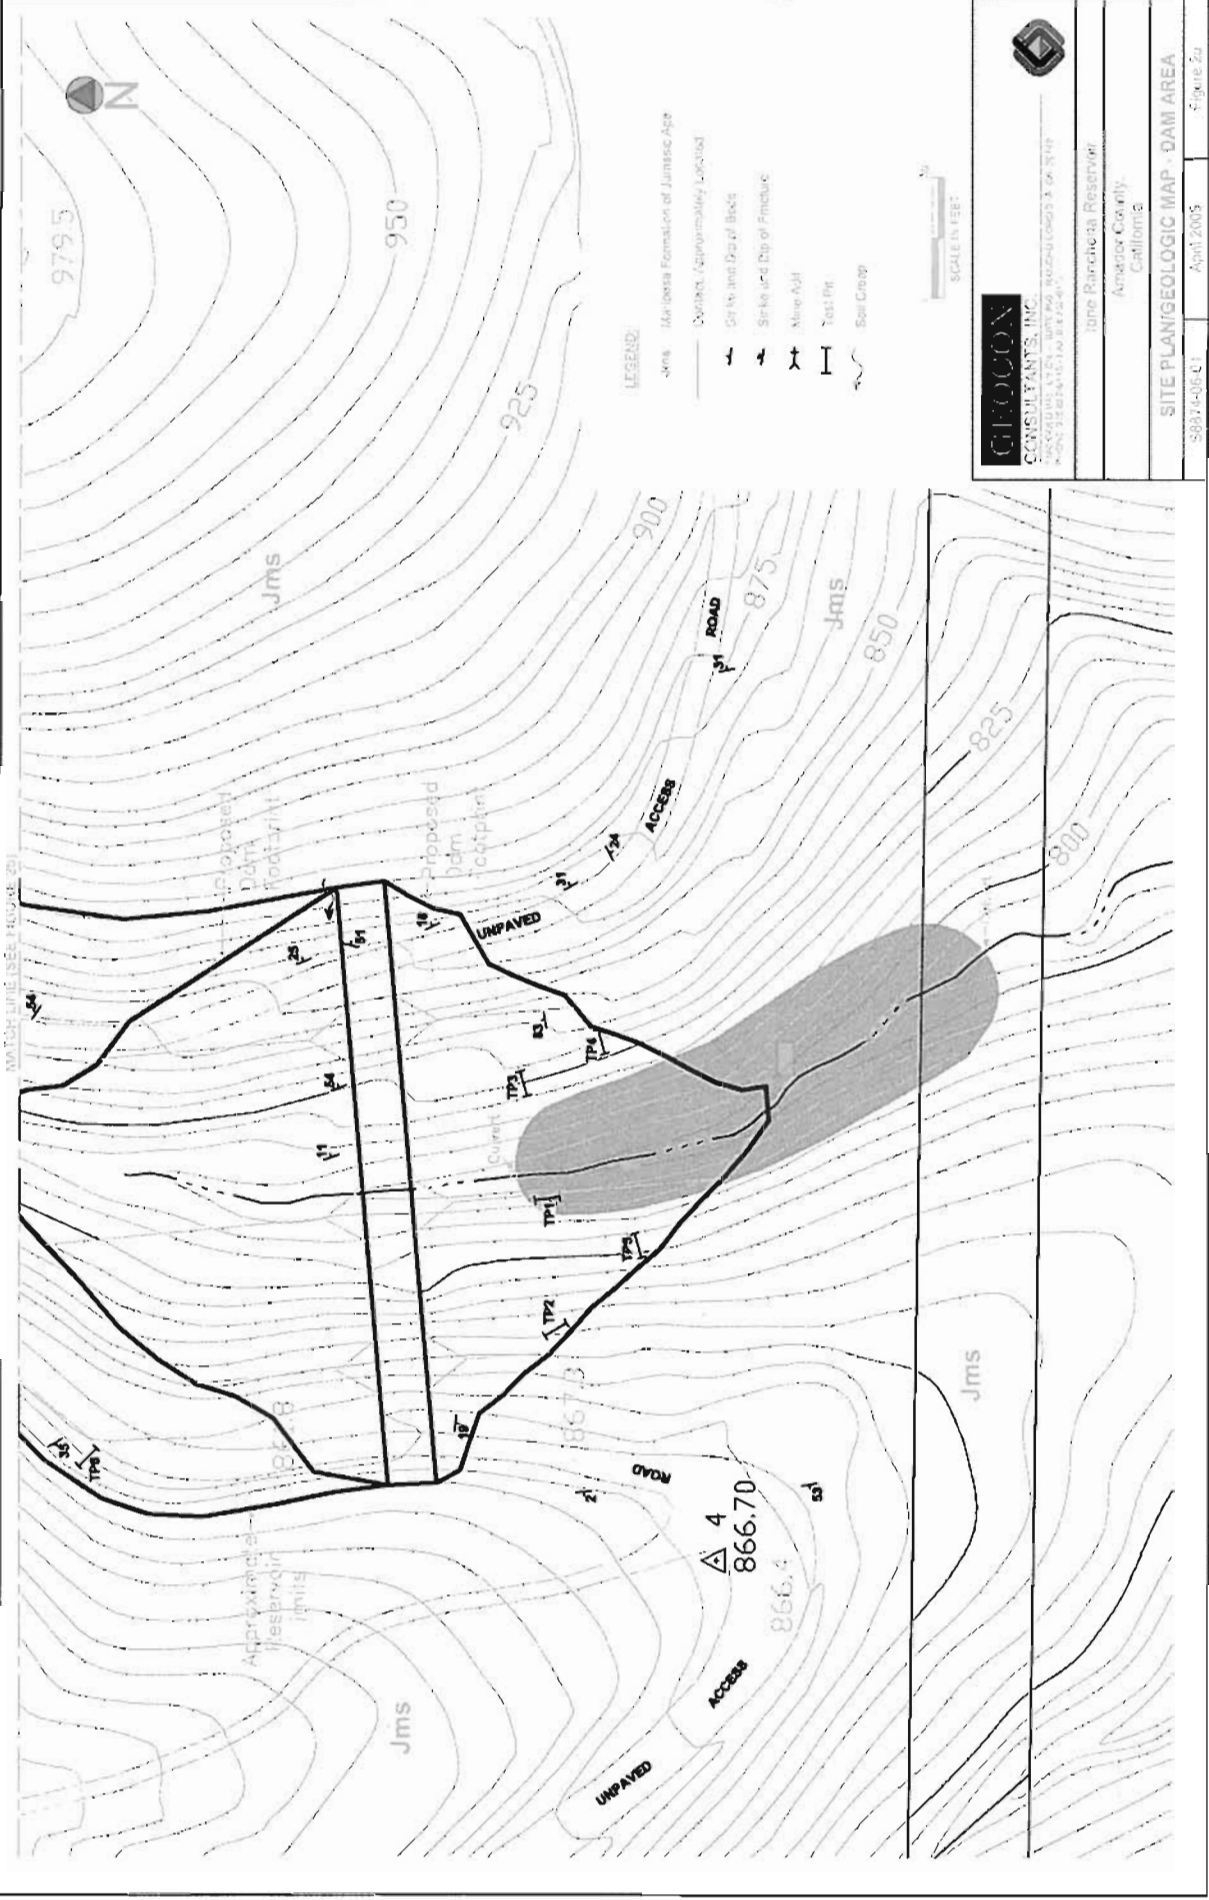
Figure 2a

Three mining adits and associated mine tailings were noted within the reservoir pool area. The approximate locations of the adits are mapped on the Site Plan/Geologic Maps, Figures 2a and 2b. The adits were caved to the entrance. Based on the size of the tailings piles adjacent to the adits, the mines are likely not very extensive. AES has indicated that these features are not considered historic structures. The abandoned Pioneer Mine was observed on the crest of a ridge approximately 1,200 feet north-northwest of the Site. HSe has indicated that there is a lateral shaft that extends from the Pioneer Mine into the canyon, upstream from the Site and not within the proposed reservoir pool area.

Soil "creep" was observed within the residual soil cover blanketing the canyon sidewalls. The creep was evidenced by the presence of several "pistol butted" trees. The creep is the result of gravity-driven colluvial movement of the thin residual soil veneer on top of the Mariposa Formation bedrock. Deep seated slope failures or evidence of landsliding was not observed at the Site or on aerial photographs of the Site.

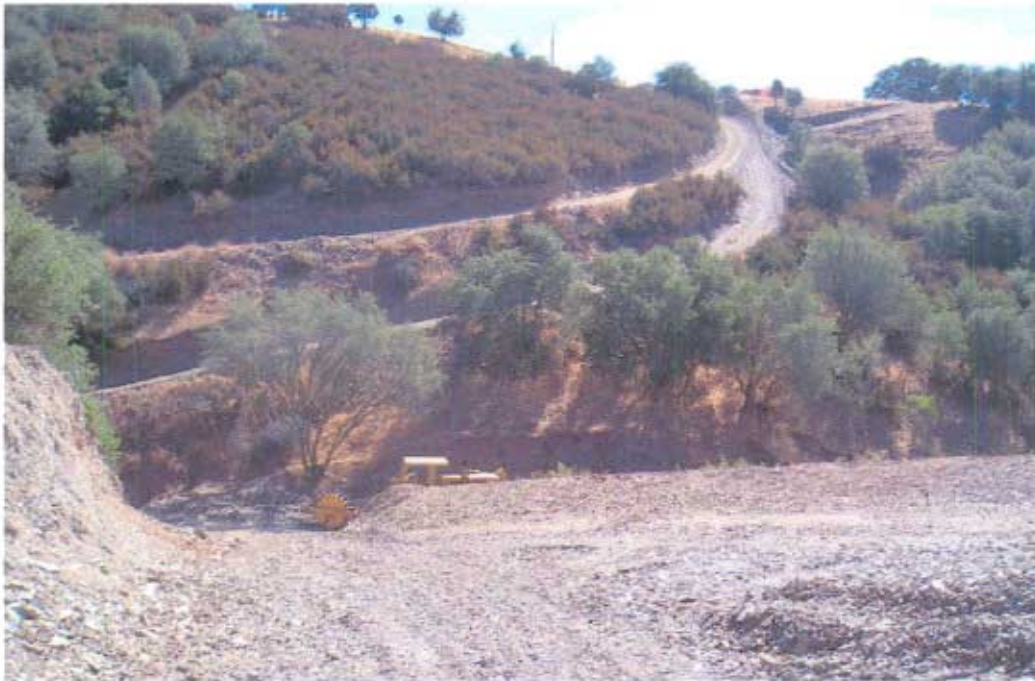
Photo No. 1 Unpaved Access Roads Traversing the Site

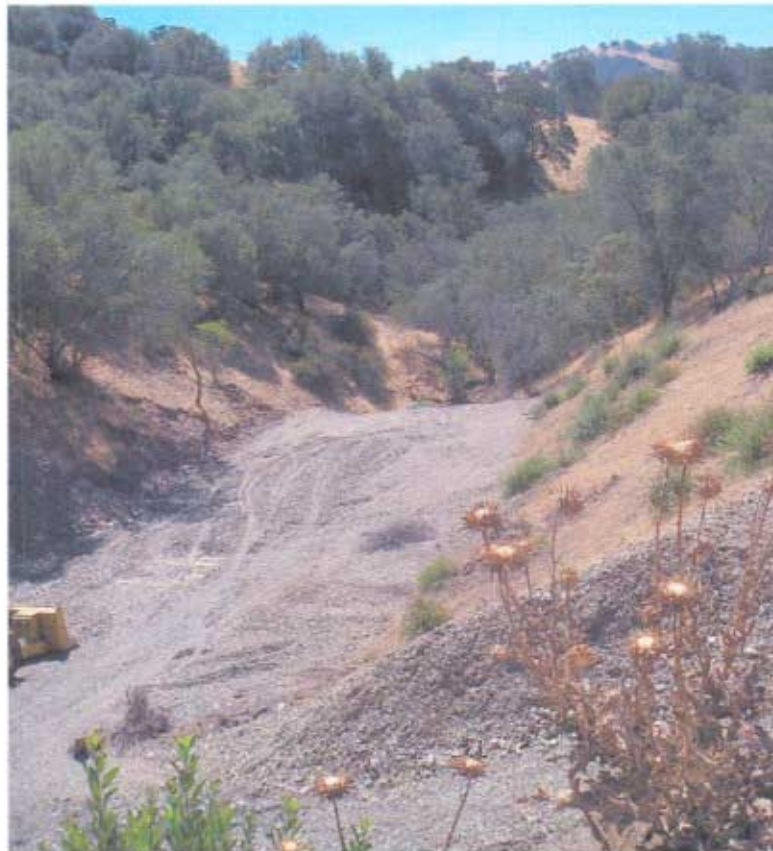
- The Site is underlain by fill material, residual soil, alluvium and Mariposa Formation bedrock.
- The maximum thickness of the fill material (at the time of our reconnaissance and field exploration) is approximately 12 feet. The fill soil is in a relatively loose condition and overlies alluvial material with a significant organic content.

Photo No. 2 Fill Material Placed in Canyon at the Site (Looking Downstream)

- The fill, alluvium and residual soil are not considered suitable foundation materials for the embankment dam. The materials should be completely removed within the footprint of the embankment. With the exception of the fill material, the depth or thickness of these materials is expected to be on the order of 5 feet or less. Localized areas could be thicker.
