## ***RESULTS OF SOIL MANTLE AND PERCOLATION TESTS***

**IONE BAND OF THE MIWOK INDIANS  
CASINO AND HOTEL SITE  
PLYMOUTH, AMADOR COUNTY, CALIFORNIA**

**APPLIED ENGINEERING AND GEOLOGY, INC.  
POST OFFICE BOX 247 • 578 E STREET  
LINCOLN, CALIFORNIA 95648  
OFFICE 916.645.6014 • FAX 916.645.6098 • EMAIL [aeg@psyber.com](mailto:aeg@psyber.com)**

MARCH 2, 2004  
(Revised 9/01/04)

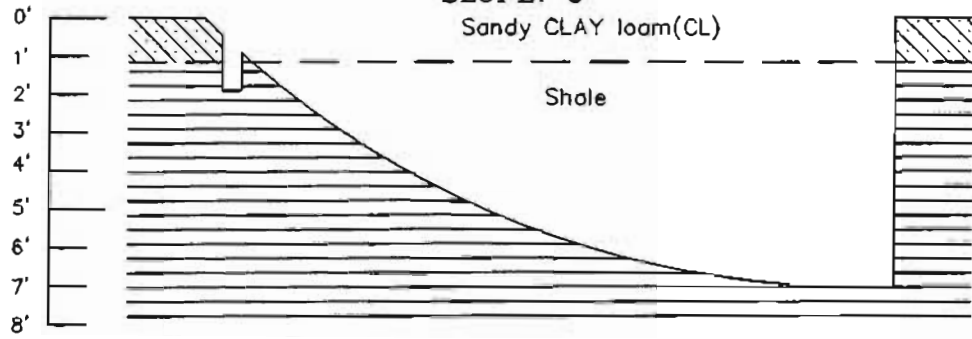
TP-1  
N 32° W  
SLOPE: 8°

Sandy CLAY loam, soil, heavy roots to approximately 2", lesser roots to 2', light brown to 7.5 YR 6/4, moderate dry strength

Shale, thin bedded with soil and clay bedding plane filling to full depth of trench, clay material at 2.5' is mostly reddish 2.5 YR 4/4, fat clay that is moist below depth of 30", shale N10°W, 86°E

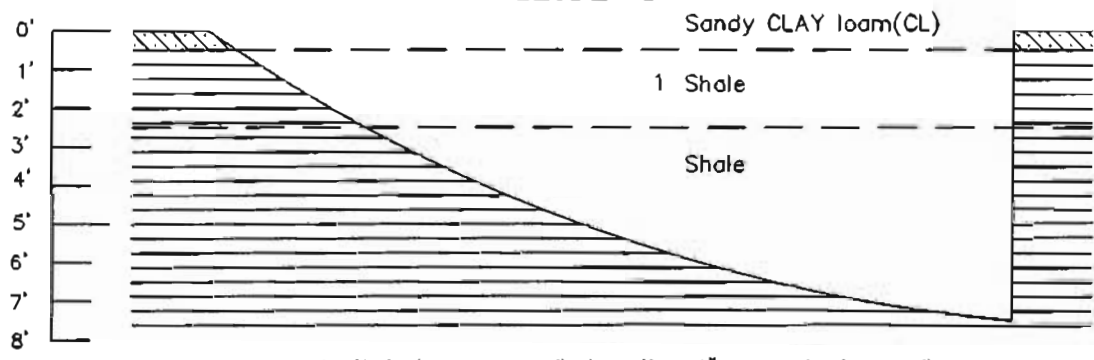
TP-2  
N 13° W  
SLOPE: 3°

Sandy CLAY loam, soil, heavy roots to 3", lesser roots to 2', dry, light brown 7.5 YR 5/2, moderate dry strength, very porous, many shale fragments 1/4" thick and 2"-4" long

Mixture of weathered broken shale and soil from above

Shale thin beds, 1/4" to 2", all planes of fractures filled with light red 2.5 YR 6/6 fat clay, moist, soil from above, shale N11°E, 57°E

1: Shale layers generally less than 1", many fractures, all bedding planes and fractures filled with soil, dry

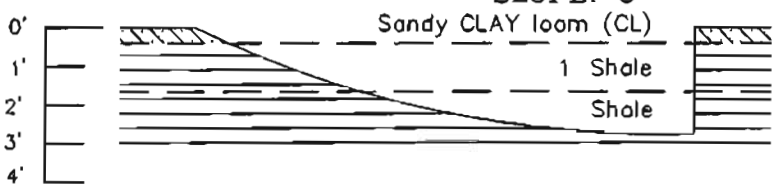
TP-3  
N 14° E  
SLOPE: 6°

Sandy CLAY loam, dry, light red-brown, 5 YR 6/3, heavy roots to 2", many roots to 18"

Broken shale, beds commonly 2"

Shale, becomes fresh, refusal at 33". Local small lenses sandstone fine to medium grained quartz and feldspar. fracture filling, moist at 24", shale N05°W, 89°E

1: Very weathered with all bedding planes and fractures filled with dry soil from above. Less weathered with depth

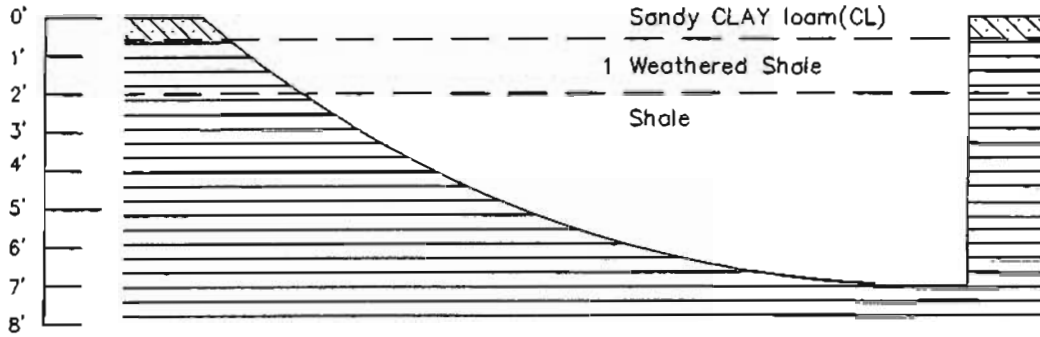
TP-6  
N 20° E →  
SLOPE: 20°

Sandy CLAY loam, light red-brown 5 YR 6/3 dry, moderate to high dry strength, heavy roots to 4".

Very porous, rock is mostly small fragments - 1/2" to 6"

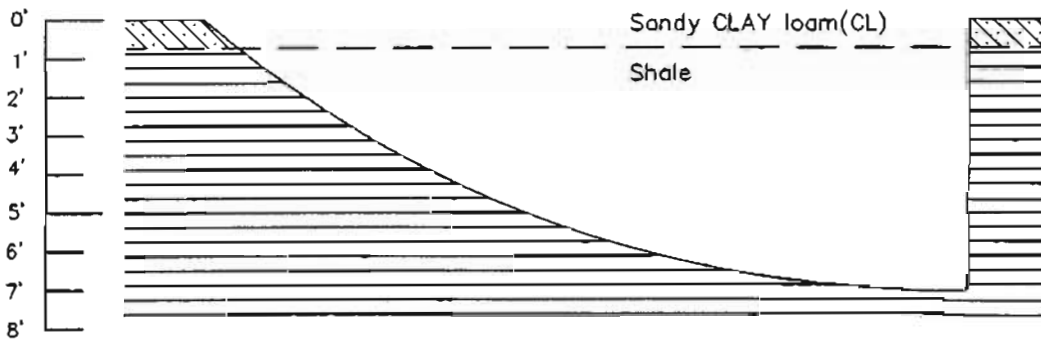
TP-7  
N 78° E →  
SLOPE: 2°

Sandy CLAY loam, abundant roots to full depth, red-gray 5 YR 5/2, dry, high dry strength

Shale, thin beds 1/2"-2" with soil in bedding planes to total depth. Upper 3' tilt down slope

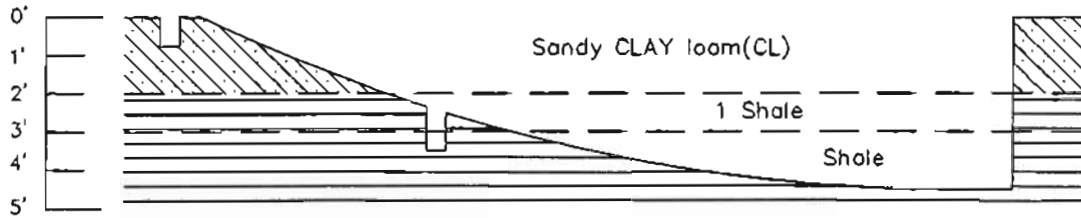
TP-9  
S 58° E →  
SLOPE: 6°

Sandy CLAY loam, gray  
5 YR 6/2, dry, high dry  
strength, very porous,  
polished on sides at  
depth of 18"  
Planes and fractures filled  
with soil from above  
Shale, hard, black, refusal  
at 4.5'

1: Shale, very broken, very weathered

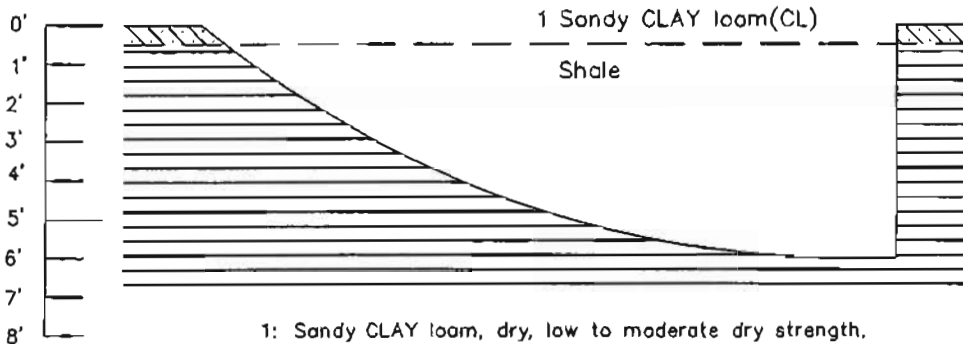
TP-10  
S 35° E →  
SLOPE: 1°

Very porous, abundant rock  
fragments throughout. Heavy roots  
to 2", many roots to 30"

Shale, thin beds 1/8" to 2", broken,  
planes and fractures filled with soil  
from above, very weathered to 6',  
hard at 6', very thin red clay on  
planes from 4'-6'. Several thin (1/2"  
to 1") sandstone beds in bottom  
of trench, very fine sand

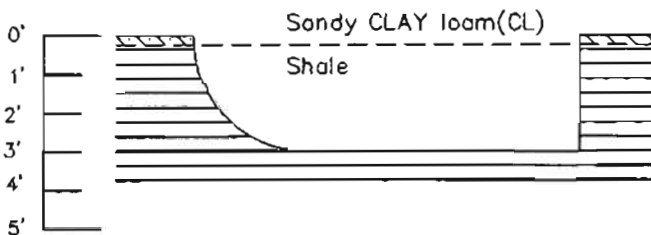
TP-10A  
N 57° E →

Sandy CLAY loam, dry

Shale, very broken, weathered, intermixed with soil from above

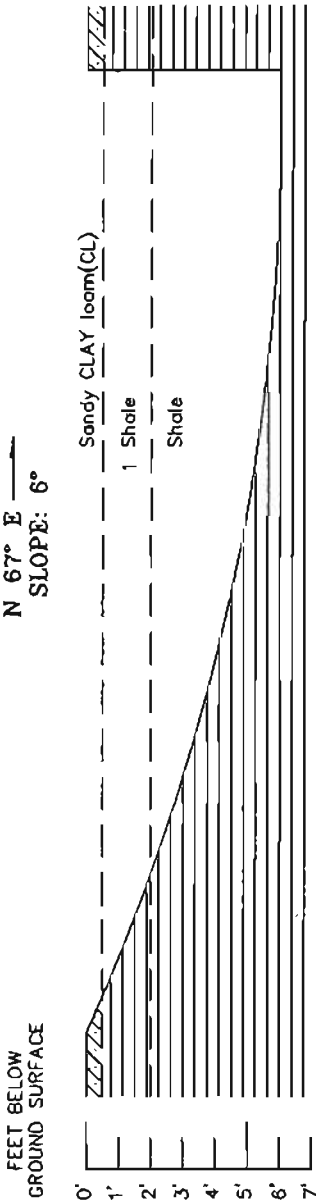
TP-12  
N 67° E  
SLOPE: 6°

Sandy CLAY loam, dry, moderate dry strength, pink-gray 5 YR 6/2 Beds tilted downslope in upper 3' bedding plane fault 19' from deep end

Shale, less to unweathered, thin beds, planes filled with clay - often red, fat, another bedding plane fault approximately 6' to NE, filled with fat red clay

1: Shale, very weathered, very broken, planes all filled with soil from above,

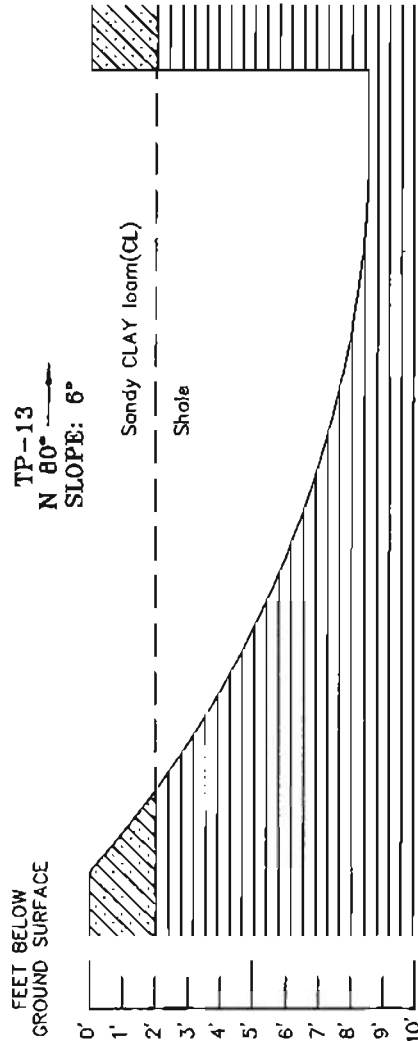
TP-13  
N 80°  
SLOPE: 6°

Sandy CLAY loam, dry, moderate dry strength, 5 YR 6/2, heavy roots to 2', many roots to 2'

Shale, very weathered, very broken, upper 3.5' tilted downslope. Local areas where material is almost a phyllite. Local clay, fat, red 2.5 YR 4/8, moist.

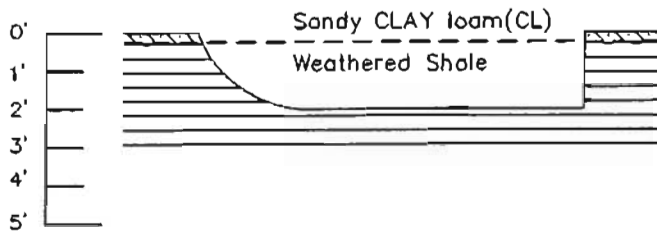
TP-12B  
N 60° E →

Sandy CLAY loam, moderate dry strength, 5 YR 6/2  
Shale, broken, weathered

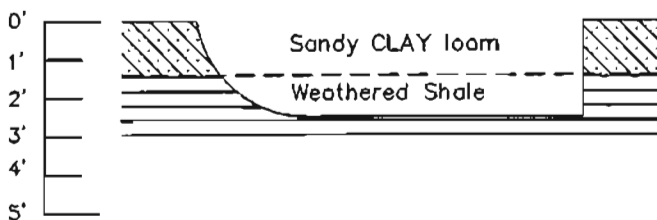
TP-13A  
N 50° W →

Sandy CLAY loam with broken shale fragments, moderate dry strength  
Shale, broken, weathered

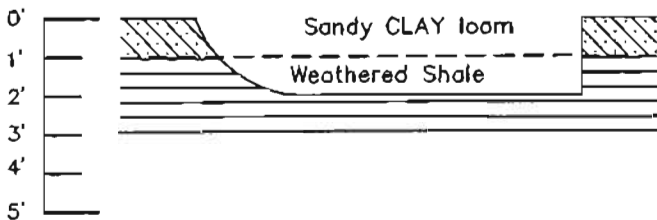
TP-13B  
N 40° W →

Sandy CLAY loam with broken shale, moderate dry strength  
Shale, broken, weathered

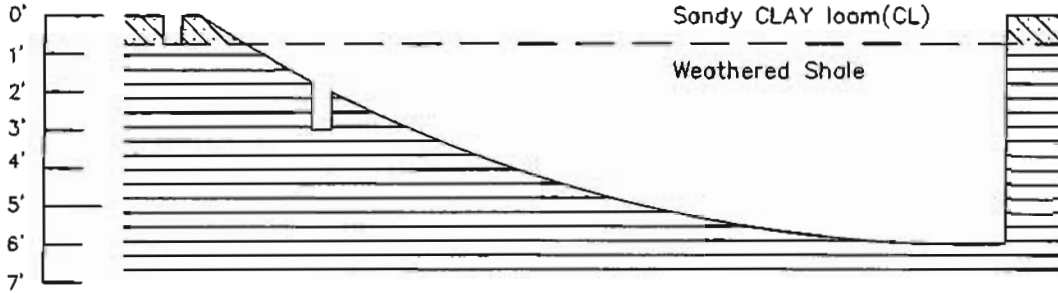
TP-17  
N 32° E →  
SLOPE: 1°

Sandy CLAY loam, pink-gray  
7.5 YR 7/2, moderate dry  
strength, heavy roots to 2",  
many roots to 3", many  
rock fragments, dry.

Shale, very broken, very  
weathered, thin beds  
1/8"-1", several bends in  
beds, probably in partially  
consolidated rock, abundant  
red clay infilling as well as  
soil from above. Red clay  
appears to be along bedding  
planes.

Shale N15°W, 62°SW

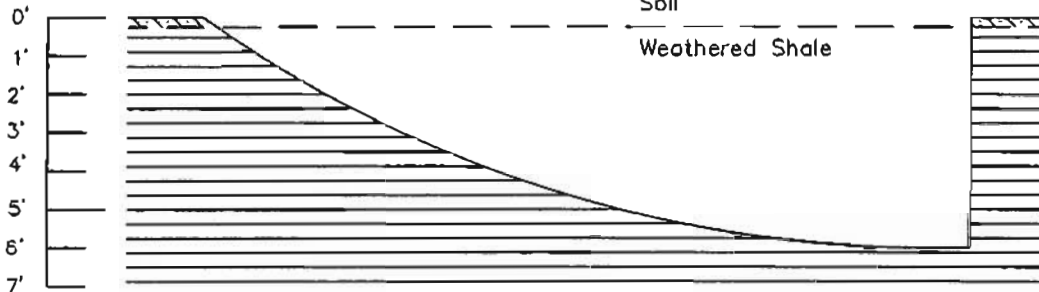
TP-18  
N 38° E →  
SLOPE: FLAT  
Soil

Soil, pinkish 5 YR 7/3, dry,  
moderate dry strength,  
obundant roots to 18",  
many roots to 3'

Shale, very weathered, very  
broken plones filled with soil  
N3°E 35' from above and  
with red clay which is along  
bedding at approximately 3'  
bgs. Bedding contorted and  
broken N05E, 43NW

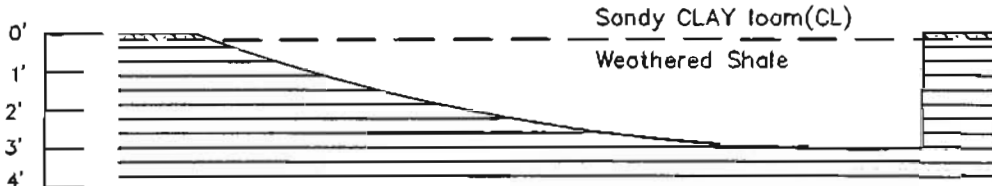
TP-19  
N 67° E →  
SLOPE: 2°

Sandy CLAY loam, heavy roots  
to 2", many roots to 2", dry,  
moderate dry strength,

Shale, very broken, weathered,  
slip plane with vertical  
movement illustrated by angle  
of bedding N0°W, 86E

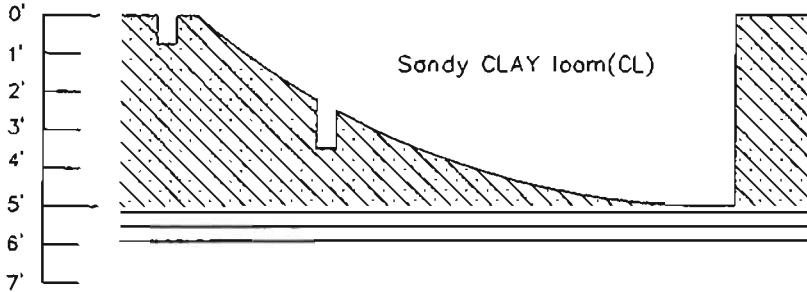
TP-27  
N 78° E →  
SLOPE: 10°

Sandy CLAY loam, very hard, with more digging found an attitude (barely any bedrock) N12°W, 75° NE, base firm hard shale, high dry strength, high polish on the sides, high clay content, light brown

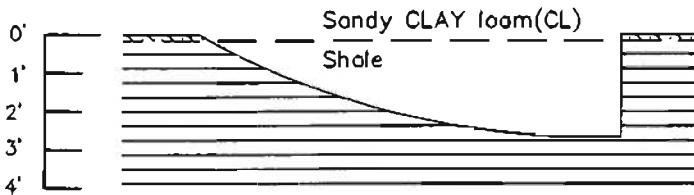
TP-28  
N 73° E →  
SLOPE: 10°

Sandy CLAY loam, low to moderate dry strength

Shale, 1/8"-1.5" beds, N18°W, 60°SW, shale is heavily fractured, soil filled fractures and bedding planes, very hard shale, no moisture, but some iron staining, one thin sandstone bed found, fine grained

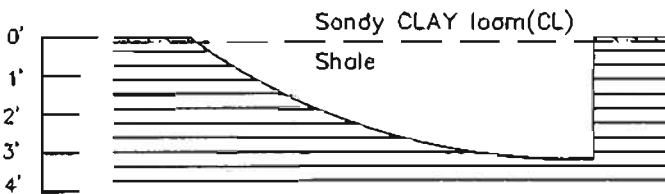
TP-29  
N 46° W →  
SLOPE: 4°

Sandy CLAY loam, very rich in organic matter

Shale, 1/6"-2" beds, some iron staining, soil filled fractures and bedding planes, N12°W, 56°SW (attitude on shale), appears to be sandstone filled fractures, roots extend to at least 2', slightly weathered at base, very hard shale
